Clare County Land Bank Authority

Pre Demolition ACM Survey

8244 East Stockwell Road

Harrison, MI

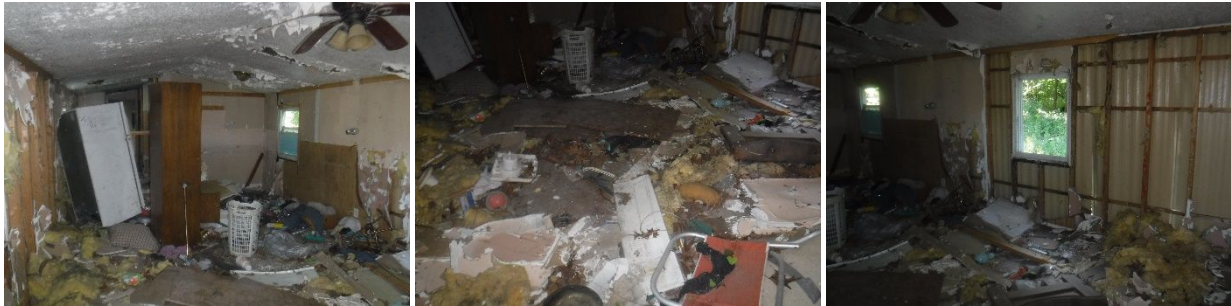
Please Note: Inspector did not enter this trailer beyond the front entry due to mass quantities of debris making an assessment of the deteriorated floor structure impractical and unsafe. The possibility exists that all ACM's were not identified within the structure. All quantities are estimated.

FS1-1, Interior, 900sqft				
HM#	Sample#	Material Description	Quantity	Asbestos Y/N
1	001, 002	Drywall/Walls/White	2000sqft	N
2	003-007	Drywall/Ceilings/Textured/White	1200sqft	N
4	008	Insulation/Loosefill/Tan	1200sqft	N
6	Assumed	Furnace	1ea	Assumed

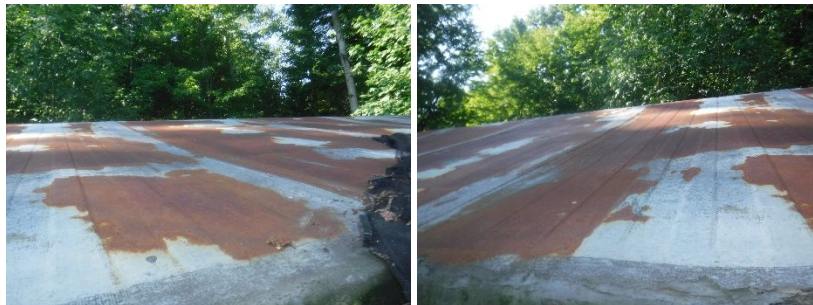
*NOTE1- Sealant/Roof/Black,Brown-Estimated quantity represents entire roof surface.

FSExt, Exterior				
HM#	Sample#	Material Description	Quantity	Asbestos Y/N
3	011	Sealant/Roof/Black,Brown/FSExt	1200sqft	Y
5	012	Caulk/Door/Tan/FSExt	3sqft	N

All regulated materials are to be handled by qualified persons. Regulated materials that may be impacted or disturbed during renovation, demolition or maintenance activities are required to be abated and disposed of properly by qualified persons. All waste accumulated must be manifested and disposed of in a type II landfill as required by regulating agencies.
