# Clare County Land Bank Authority

## Pre Demolition ACM Survey

8400 South Harrison Avenue

8/5/2024

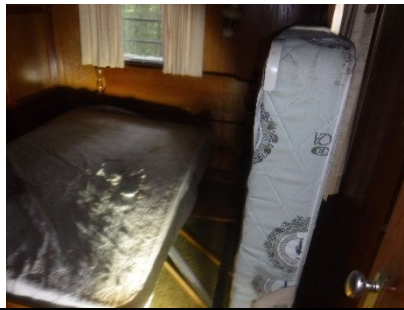
FS1-2, North Bed Room, 70sqft				
HM#	Sample#	Material Description	Quantity	Asbestos Y/N
1	001	Flooring/Brown,Black	70sqft	N
13	002	Adhesive/WallPanel/White	25sqft	N

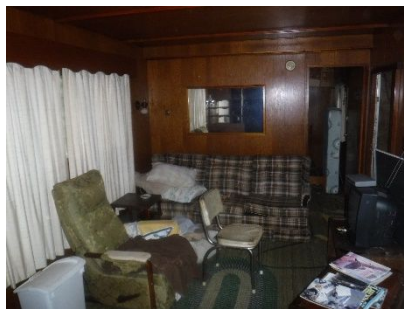
FS1-3, Living Room, 129sqft				
HM#	Sample#	Material Description	Quantity	Asbestos Y/N
1	001	Flooring/Brown,Black	129sqft	N
13	002	Adhesive/WallPanel/White	25sqft	N

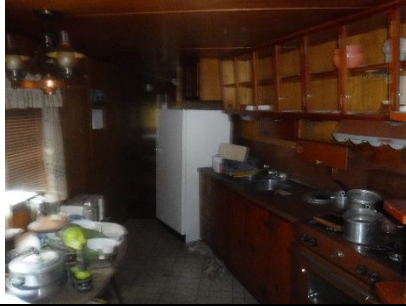
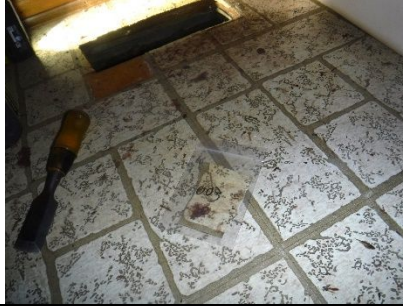
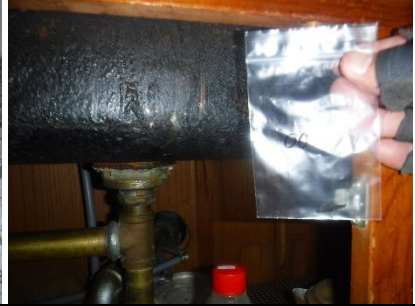
**FS1-4, Kitchen, 96sqft**

HM#	Sample#	Material Description	Quantity	Asbestos Y/N
2	003	FloorTile/12x12/Cream	200sqft	Y
13	002	Adhesive/WallPanel/White	20sqft	N
14	004	Undercoat/Sink/Black	10sqft	Y

All regulated materials are to be handled by qualified persons. Regulated materials that may be impacted or disturbed during renovation, demolition or maintenance activities are required to be abated and disposed of properly by qualified persons. All waste accumulated must be manifested and disposed of in a type II landfill as required by regulating agencies.

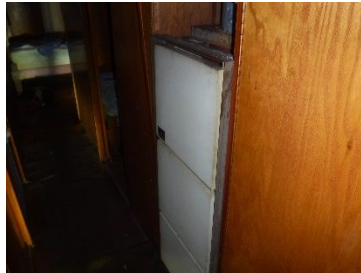
**FS1-5, Hallway, 33sqft**

\*NOTE1- Furnace-Assumed due to internal components.

HM#	Sample#	Material Description	Quantity	Asbestos Y/N
1	001	Flooring/Brown,Black	33sqft	N
13	002	Adhesive/WallPanel/White	15sqft	N
23	Assumed	Furnace	1ea	Assumed

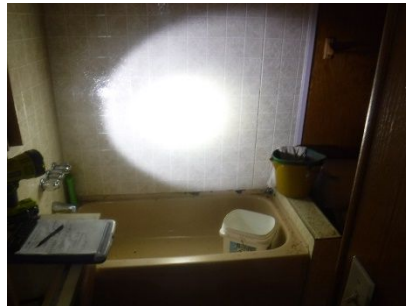
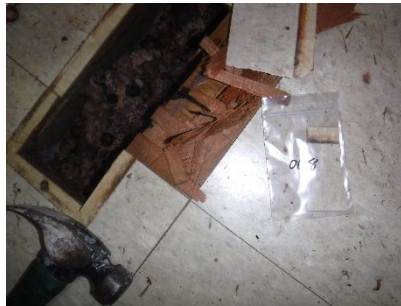
**FS1-6, Bath Room, 45sqft**

HM#	Sample#	Material Description	Quantity	Asbestos Y/N
1	001	Flooring/Brown,Black	40sqft	N
3	008	FloorTile/12x12/White	40sqft	Y
13	002	Adhesive/WallPanel/White	15sqft	N
15	009	Adhesive/ShowerPanel/White	50sqft	N
16	010	Caulk/Sink/White	1sqft	N

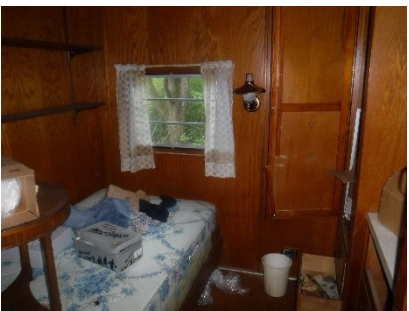
**FS1-7, Middle Bed Room, 56sqft**

HM#	Sample#	Material Description	Quantity	Asbestos Y/N
1	001	Flooring/Brown,Black	56sqft	N
13	002	Adhesive/WallPanel/White	15sqft	N

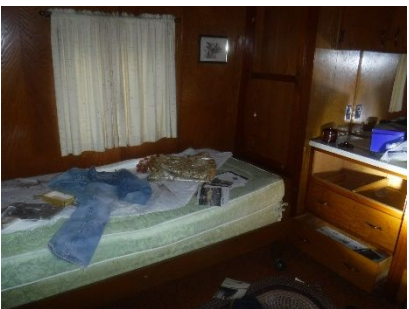
**FS1-8, South Bed Room, 68sqft**

HM#	Sample#	Material Description	Quantity	Asbestos Y/N
1	001	Flooring/Brown,Black	68sqft	N
13	002	Adhesive/WallPanel/White	20sqft	N

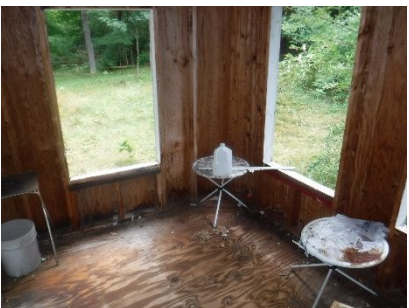
**FS1-9, South Addition, 80sqft**

HM#	Sample#	Material Description	Quantity	Asbestos Y/N
				N

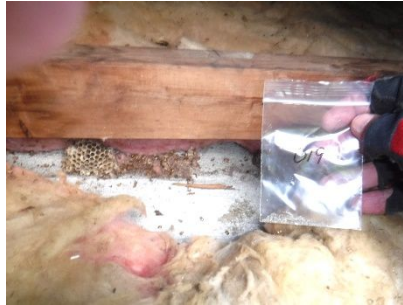
\*NOTE1-RoofCoating/MobileHome/Silver-This material is the original mobile home roof and was accessed and sampled at a small opening created in the soffit above the front door. A second roof structure has been built above the mobile home.

FSAttic, 600sqft				
HM#	Sample#	Material Description	Quantity	Asbestos Y/N
12	005-007	Insulation/Loosefill/Brown/FSTrailerAttic	600sqft	N
4	019	RoofCoating/MobileHome/Silver	600sqft	Y

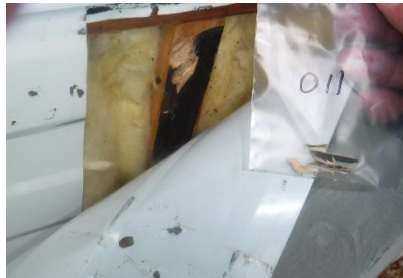
\*NOTE2- Adhesive/Framing/Black-A small amount of this material was observed and sampled at a small area of removed siding. In order to estimate quantity, additional siding will need to be removed (See pic in FSExt).

FSExt, Exterior				
HM#	Sample#	Material Description	Quantity	Asbestos Y/N
17	011	Adhesive/Framing/Black	Undetermined	Y
18	012	Sealant/Siding/Gray,Cream	100sqft	N
19	013	Caulk/Additions/White	20sqft	N
20	014	Caulk/Addition/Window/White	10sqft	N
21	015	Sealant/Window/Cream,Gray	15sqft	N
5	020	VaporBarrier/Roof/Black	1500sqft	N
6	021	Shingle/Roof/Black	1500sqft	N
7	022	VaporBarrier/AdditionRoof/Black	200sqft	N
8	023	Shingle/AdditionRoof/Gray	200sqft	N

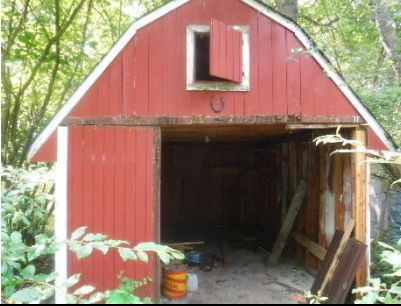
**FSShed, 275sqft**

<b>HM#</b>	<b>Sample#</b>	<b>Material Description</b>	<b>Quantity</b>	<b>Asbestos Y/N</b>
9	024	VaporBarrier/ShedRoof/Black	600sqft	N
10	025	Shingle/ShedRoof/Gray	600sqft	N
11	026	Shingle/ShedRoof/Black	600sqft	N
